MEMO

Subject: Beal Barren Pond Removal (Project# 114-560420) - Final

**BARREN POND REMOVAL
BEAL MTN MINE, MONTANA
TETRA TECH PROJECT 114-560420.200**

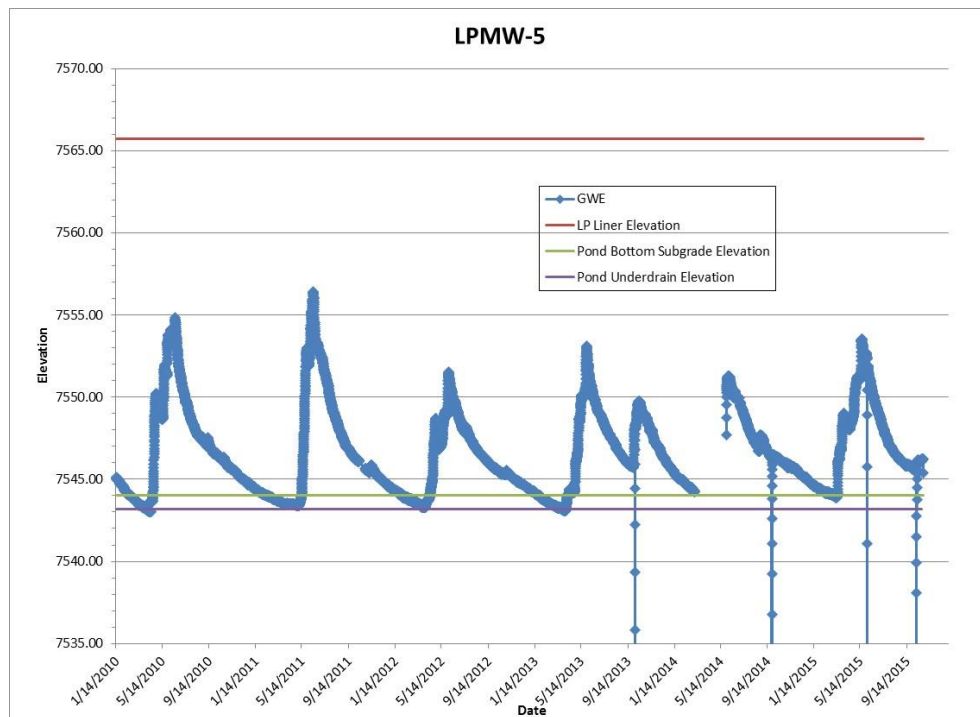
Figure 4. LPMW-5 Groundwater Elevations

During removal activities, groundwater elevations in monitoring well LPMW-5 (located between the leach pad and Barren Pond) did not appear to be influenced by removal actions and were similar to previous data. This data is presented in the following graph. Note, the subgrade elevation of the pond bottom was surveyed on October 28, 2015, to be approximately 7,544 feet above mean sea level, which is well below previously recorded groundwater elevations.

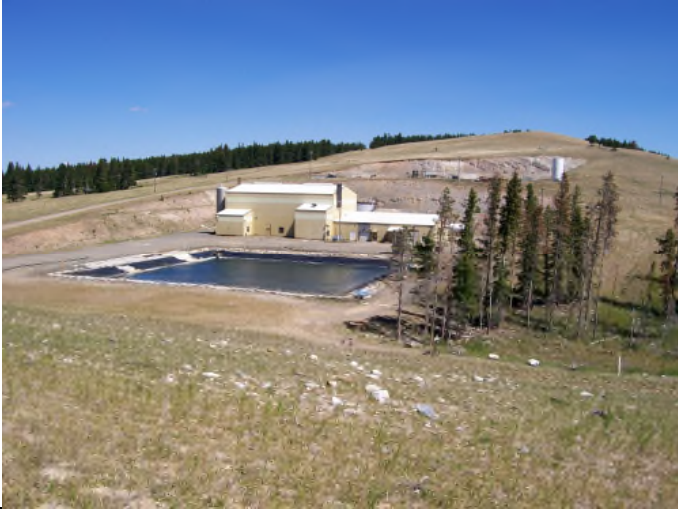
PHOTOGRAPH 1 Barren Pond 2006.

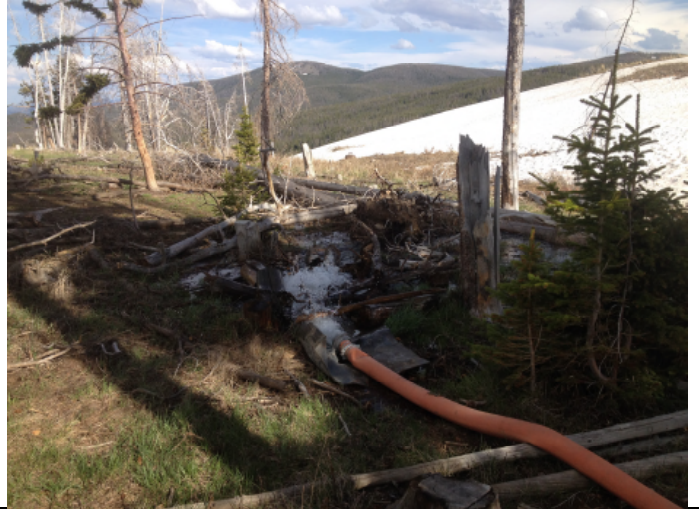
PHOTOGRAPH 2 June 3, 2014 Initial dewatering with discharge to the east.

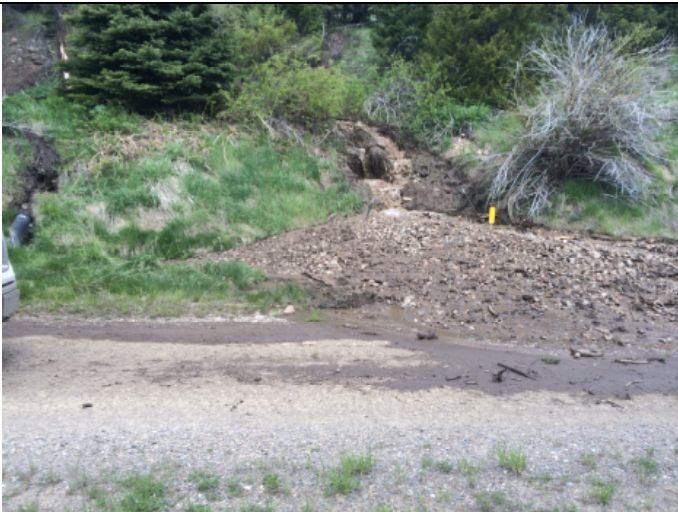
PHOTOGRAPH 3 June 6, 2014 small landslide.

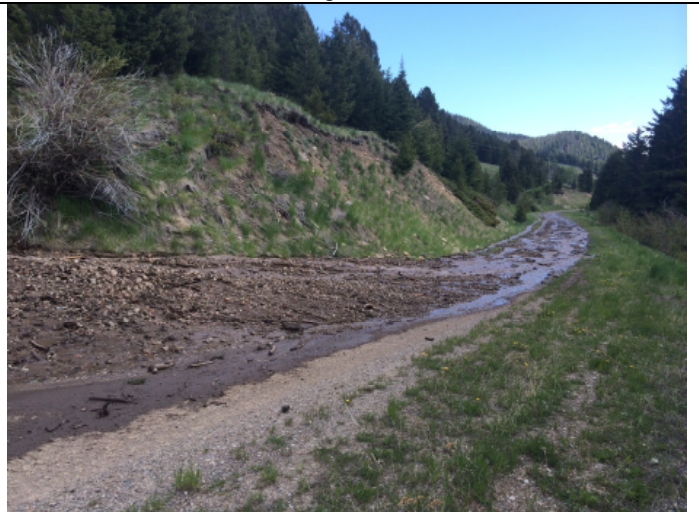
PHOTOGRAPH 4 June 6, 2014 small landslide

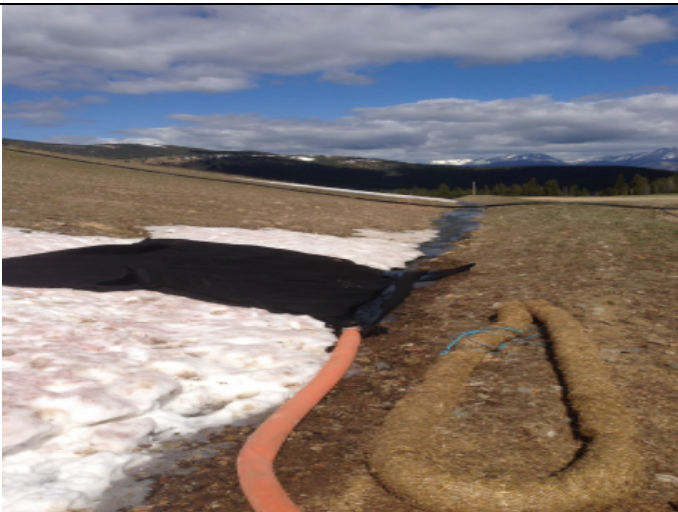
PHOTOGRAPH 5 June 12, 2014 dewatering discharge to leach pad runoff ditch.

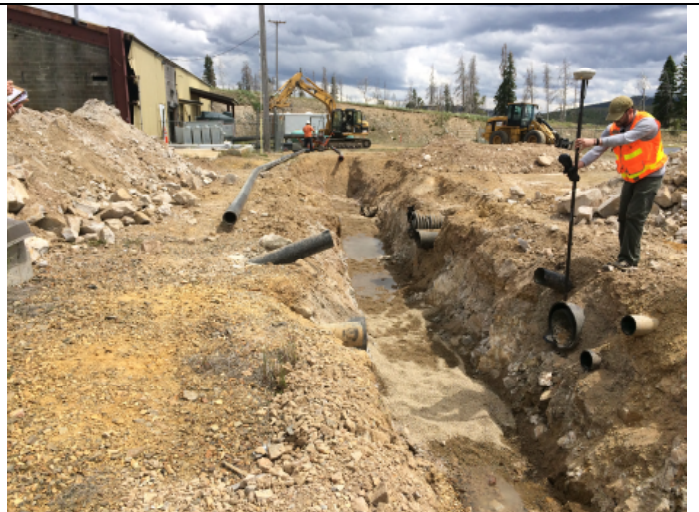
PHOTOGRAPH 6 June 22, 2015 Surveying buried infrastructure. Note groundwater in trench.

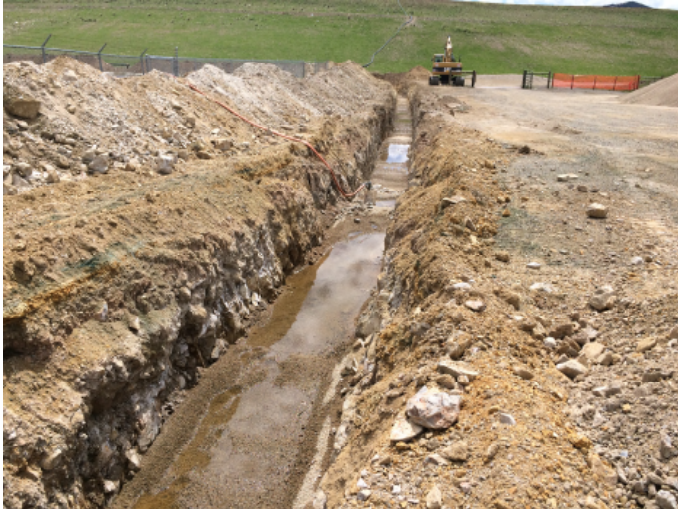
The trench excavated north and west of the Barren Pond for the installation of water treatment piping encountered bedrock and unexpected groundwater. Visual observations of the trench side walls indicated a primary and secondary fracture system within the rock. The primary fractures paralleled bedding planes and trended north-south. Secondary fractures were generally perpendicular to primary fractures and trended east-west. Visual observations further suggest that the primary fractures were sealed shut by a precipitate and the groundwater appeared to be moving through the secondary fracture system.

PHOTOGRAPH 7 June 22, 2015 Trench for water treatment influent and reject pipes west of pond. Note bedrock and groundwater.

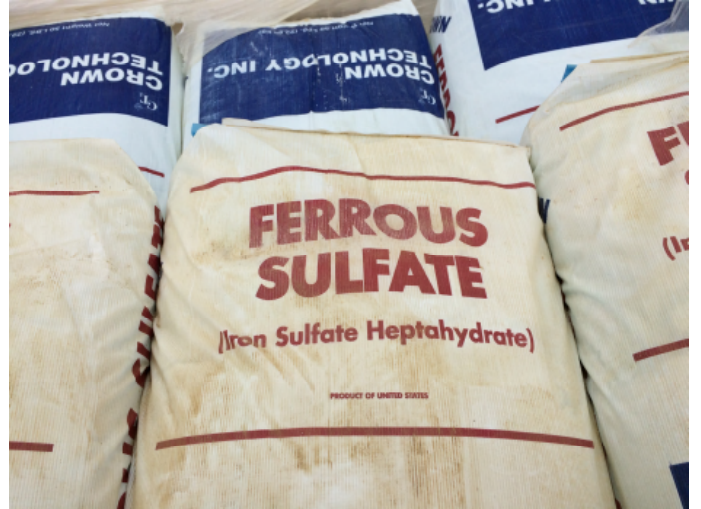
PHOTOGRAPH 8 Sept 14, 2015 Ferrous Sulfate used to stabilize HCN.

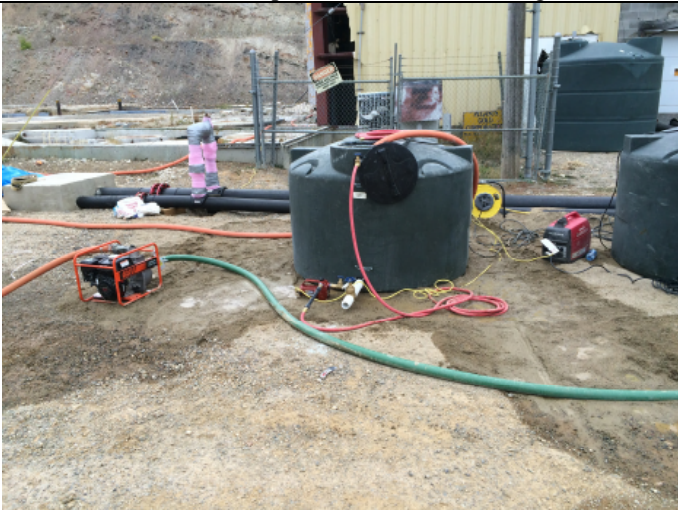
PHOTOGRAPH 9 Ferrous Sulfate mixing tanks.

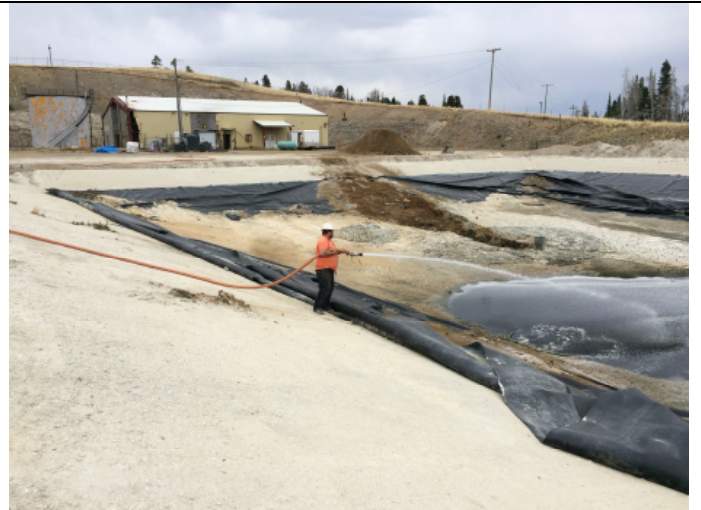
PHOTOGRAPH 10 Sept 14, 2015 Applying initial dose of ferrous sulfate.

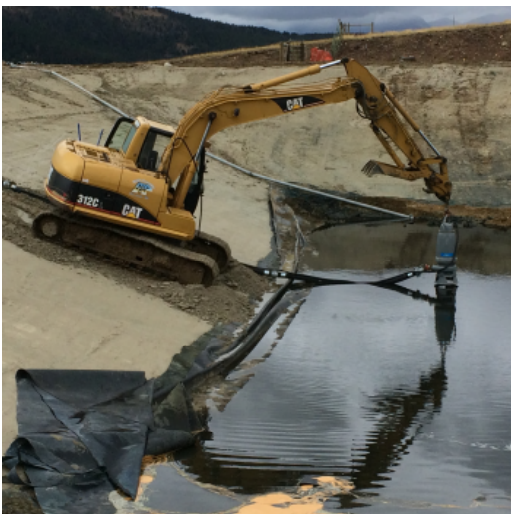
PHOTOGRAPH 11 September 16, 2015 setting slurry pump.

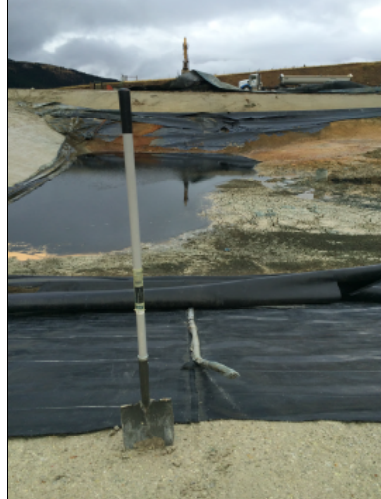
PHOTOGRAPH 12 Piping between PVC liners.

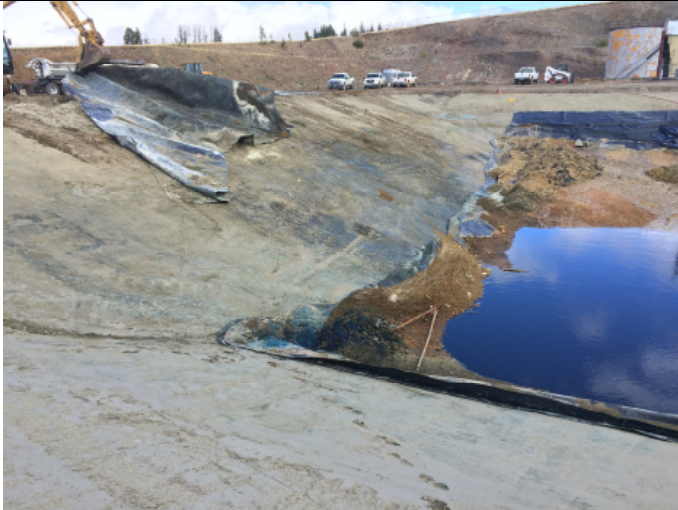
PHOTOGRAPH 13 Surficial staining of clay beneath PVC liner west wall.

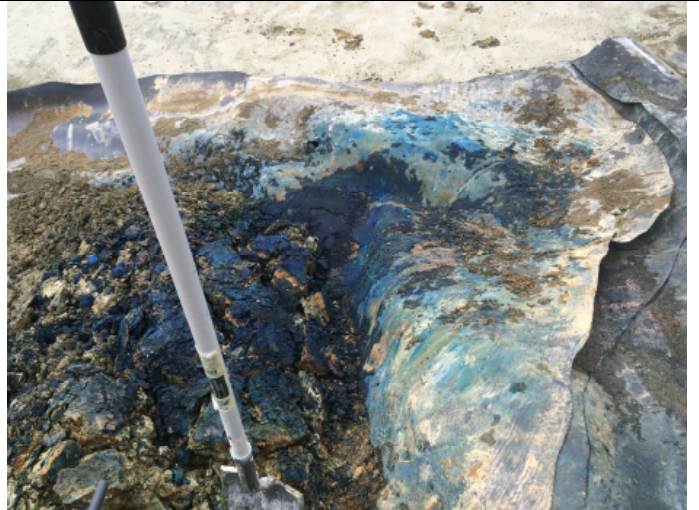
PHOTOGRAPH 14 Biosolid staining on top of PVC liner.

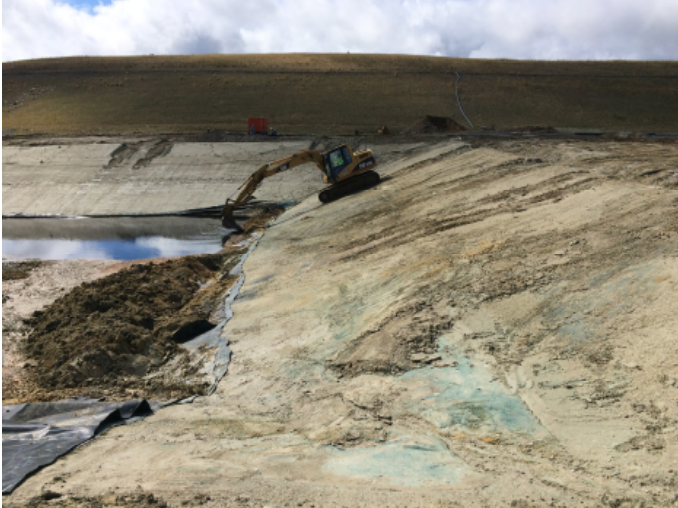
PHOTOGRAPH 15 Surficial staining of clay NW corner.

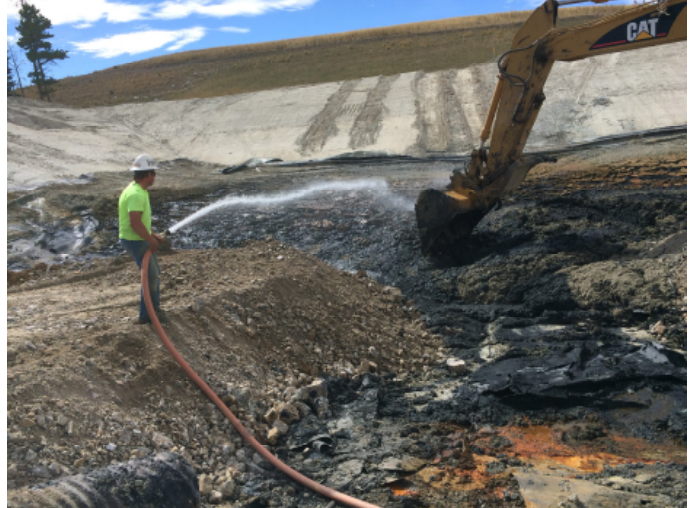
PHOTOGRAPH 16 Applying ferrous sulfate and mixing with excavator.

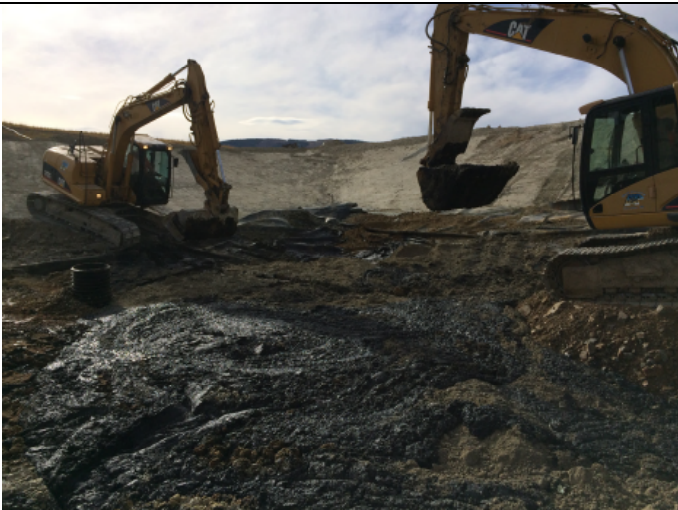
PHOTOGRAPH 17 Thickening biosolids with sidewall clay.

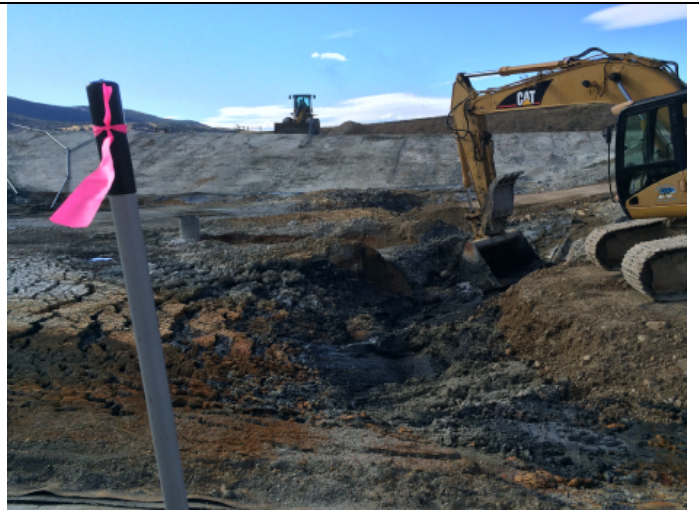
PHOTOGRAPH 18 Removing thickened biosolids.

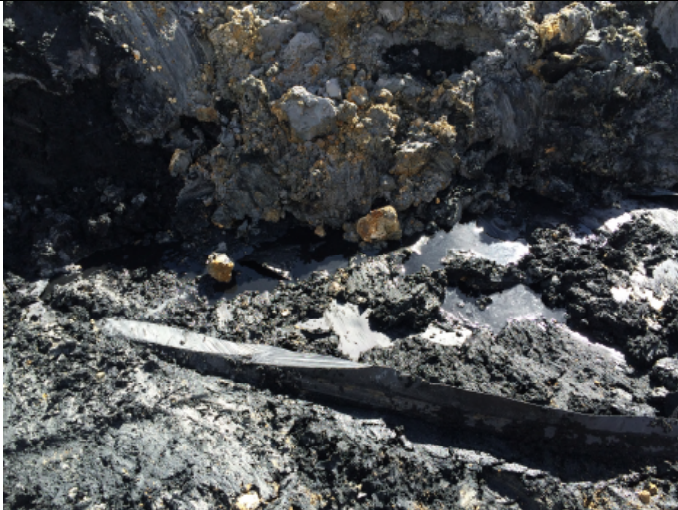
PHOTOGRAPH 19 Faulty seam in uppermost bottom PVC liner.

1530	seam of top liner in NW corner bottom do not appear welded or were not welded properly since tore apart easily in N/S direction and straight. very wet between liners. Another E/W seam same way Move to E ramp to mix in FeSO ₄ . West Ramp Needs extending adding bentonite. Material on E side of pond much wetter and looser than West side.		
1640 1700	loader returned from repository to extend West ramp 320 ex moving to West ramp, loader extending east ramp, dosing w/ FeSO ₄		
1745	320 ex shutting down to fuel loader still stacking @ repository		
1830	Leaving Site Downwind Cab 320 ex		
Hen Peak STEL TWA	26.5 0.5 0.0	2.0 0.0 0.0	Load count 1

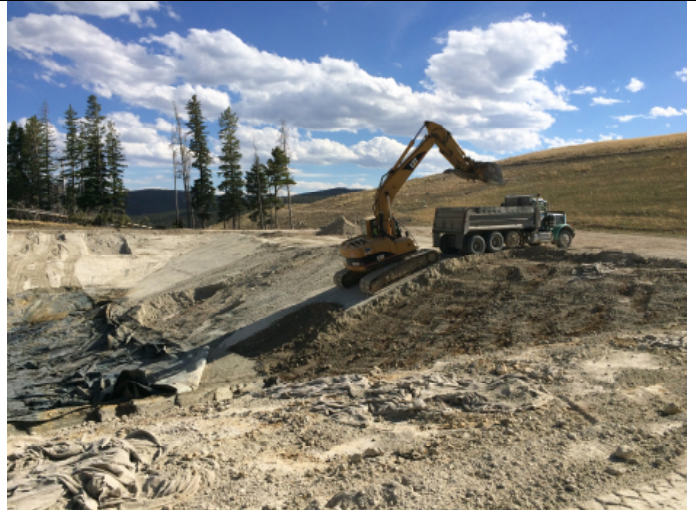
PHOTOGRAPH 20 September 25 removing upper sidewall clay.

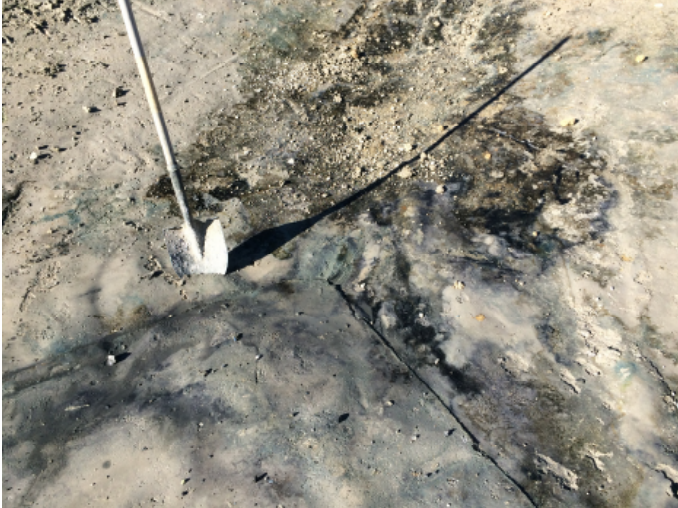
PHOTOGRAPH 21 Staining beneath PVC liner SW corner.

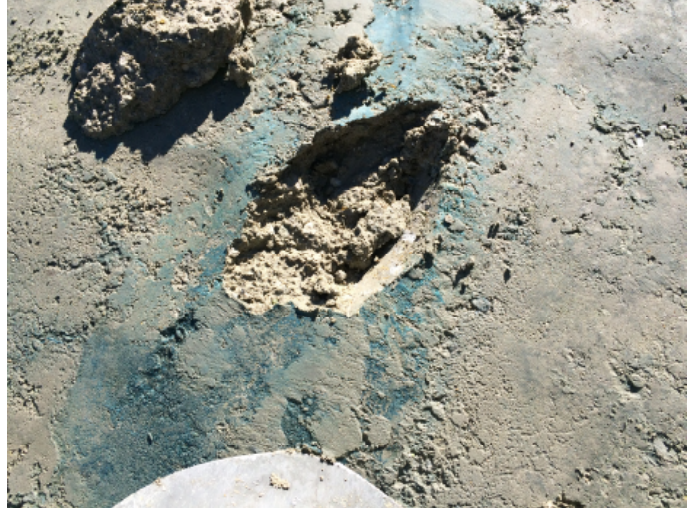
PHOTOGRAPH 22 Surface staining with little penetration.

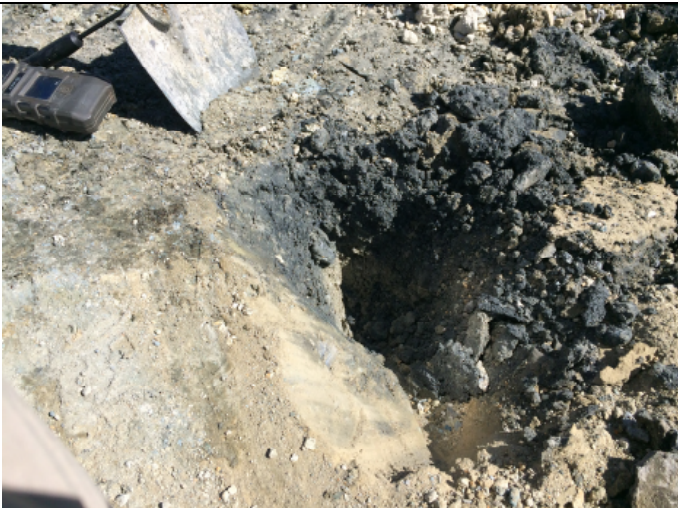
A few locations of surface staining that were probed exhibited staining penetration up to 12 inches. During removal of pond sidewall clay, the pond corners often exhibited black staining beneath an unstained surface. All staining beneath the PVC liner was found at elevations at or below the top elevation of biosolids within the liner, with the exception of surficial staining on the west wall. Stained clay was stripped and placed in the temporary repository with the biosolids. Unstained sidewall clay and pond bottom clay were stripped separately and each stockpiled separately outside of the temporary repository. A geotextile fabric was encountered between the clay and native soils. Pond sidewall clay was generally found to be approximately 2 to 2.5 feet thick. Bottom clay was generally found to be 2.5 to 3 feet thick. Black staining of native soils on the pond bottom was common. Sub soil staining generally did not penetrate greater than four inches. Tetra Tech collected two, five-point composite samples of stained native subsoils and one water sample from a shallow pool that formed in a depression for laboratory analysis. Results are presented in Table 2 below. Stained subsoils were then removed to the extent feasible and stockpiled in the temporary repository. Despite encountering groundwater in shallow trenching north and west of the Barren Pond, no groundwater seepage from pond sidewalls was observed during removal activities. Groundwater was only encountered at the very bottom of the pond.

PHOTOGRAPH 23 Surface staining with up to 12-inches of penetration

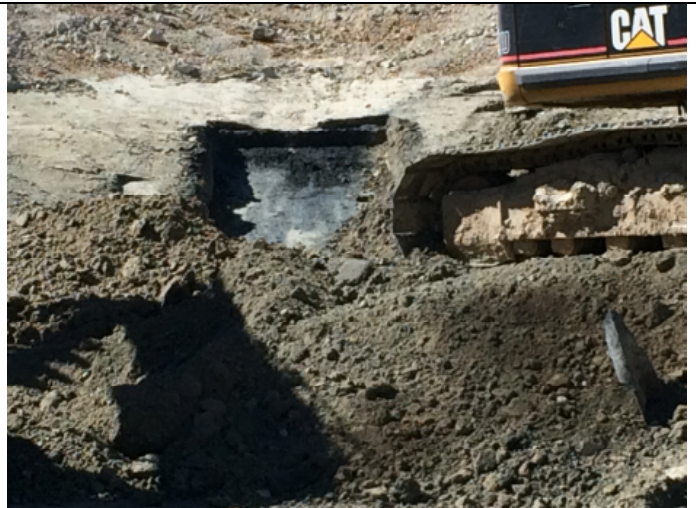
PHOTOGRAPH 24 Staining beneath unstained surface.

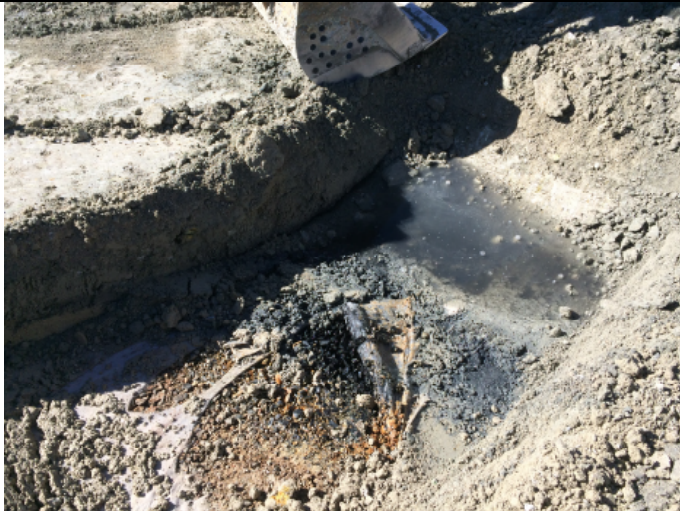
PHOTOGRAPH 25 Subsoil staining, with perched groundwater. Note geotextile fabric and lack of clay stain overlying.

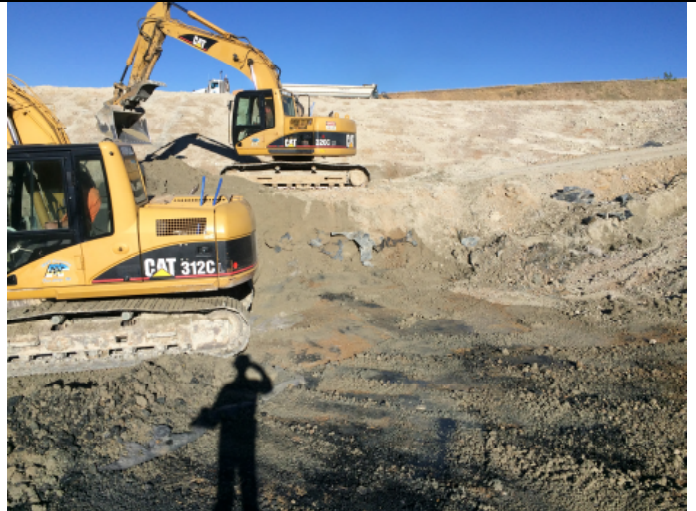
Review of these results suggest the two PVC linings and the 2 to 3 feet of clay leaked sufficiently to allow cyanide into the underlying soils and groundwater, and that the biosolids were in fact a source of cyanide to the surrounding area.

PHOTOGRAPH 26 Subsoil staining of pond bottom after removal of clay and geotextile.

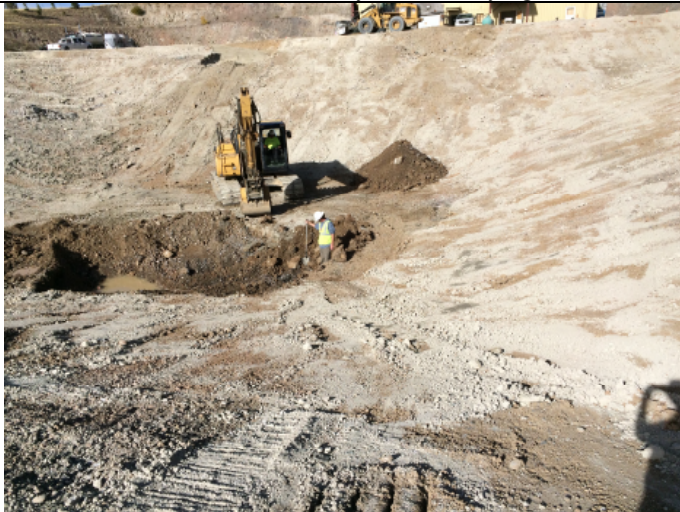
PHOTOGRAPH 27 Pond Underdrain found after searching west (left) to east (right). Note groundwater at or above drain elevation.

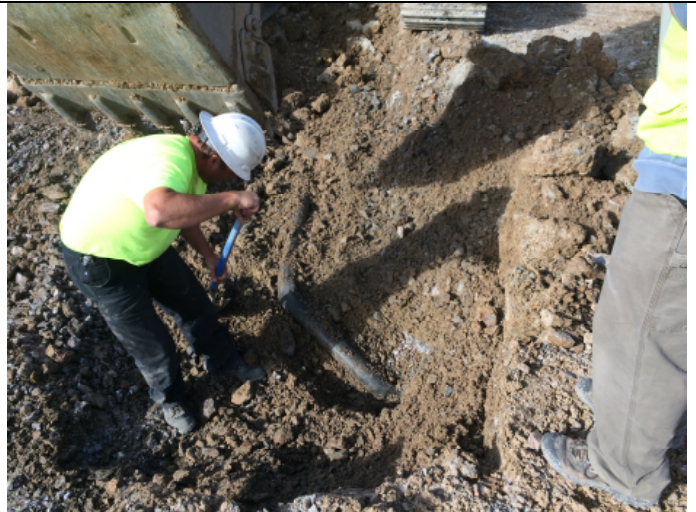
1. The orientation of the drain was found to be more southeasterly than south and exited the southeast corner of the pond.
2. Upon excavation, the drain pipe was found to have been damaged during construction. The 4-inch high density polyethylene (HDPE) pipe was found severed approximately five feet downgradient of the perforated section. The perforated side of the severed pipe was found to be bent approximately 45 degrees to the east. Additionally, projection of the perforated section was at an elevation approximately 8 to 10-inches higher than the corresponding downgradient mate. Upon exposing the downgradient mate to the damaged pipe, Tetra Tech confirmed that this pipe did report to the northeast corner of the BCD pond and was the same pipe outlet being sampled as location BCD-Barren. The origins of a second pipe outlet at the northeast corner of the BCD pond remain unknown.

PHOTOGRAPH 28 Excavating pond underdrain. Note pipe was bent at 45 degrees upon excavation.

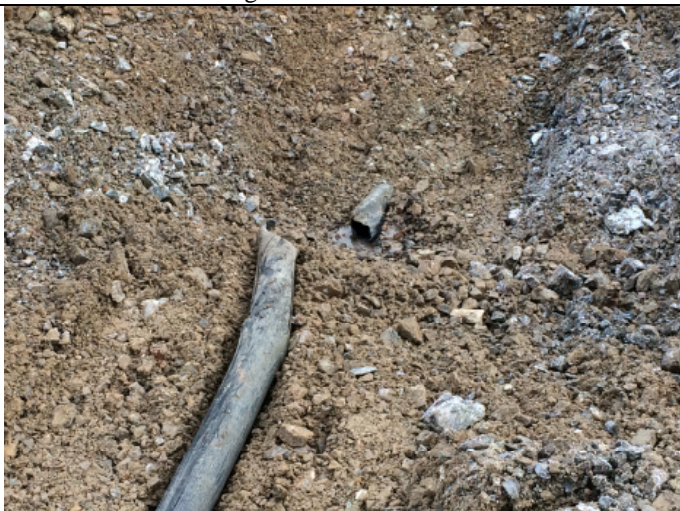
PHOTOGRAPH 29 Mating pond underdrain inlet.

The pond under drain intake was fitted with a four inch perforated riser pipe approximately one foot in length and a depression excavated around the intake area to facilitate drainage of the area over winter.

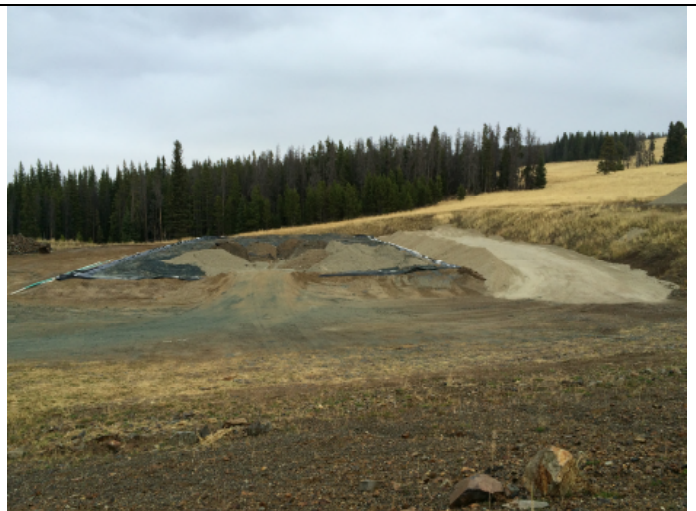
PHOTOGRAPH 30 Lined drying pad/temporary repository center. Sidewall clay to right and bottom clay far right edge of photo.

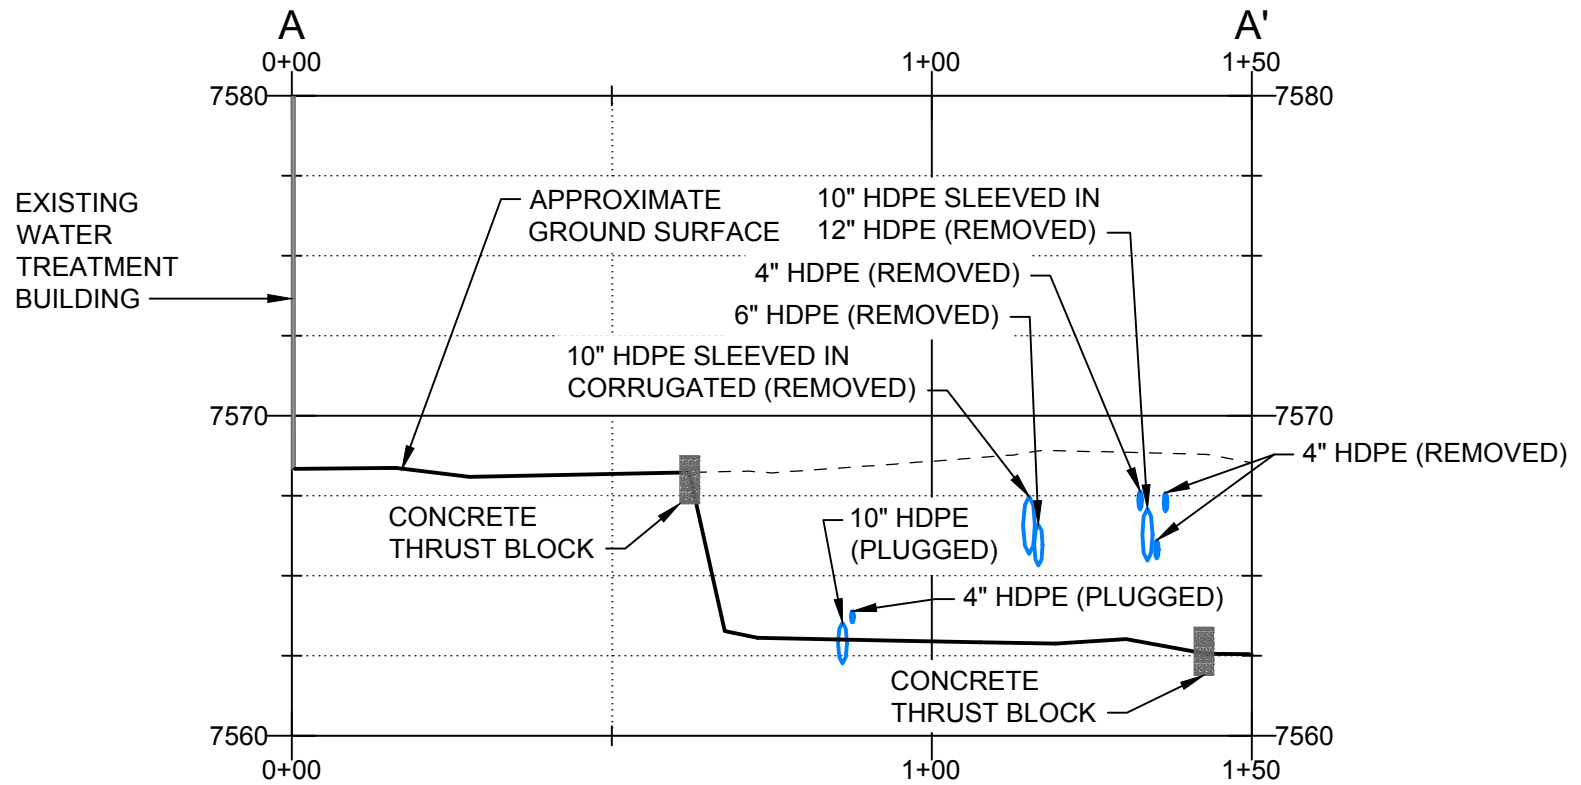
**Barren Pond Investigation
Buried Utilities Profile
Beal Mountain Mine
Silver Bow County, Montana
FIGURE 3**

The majority of infrastructure encountered in trenching near the northwest corner of the pond were later removed (**Figure 1**). Three buried lines encountered near the southwest corner of the pond were left in place after tapping them with a ¼ inch drill hole encountered either water or vacuum within. The northern most line bubbled water through the tap hole to a fountain height of approximately six inches. Flow from the tap hole subsided within 20 minutes. The middle line drew air in and thus exhibited a slight vacuum when tapped. The southernmost line also drew air in and thus exhibited a slight vacuum when tapped. However, shortly after tapping the southernmost line, water began flowing from the connection point of the RO influent line at the southeast corner of the pond. Based on these observations, pressure gauges were installed on these three lines for further evaluation while the water treatment system was operating. During water treatment operations (active pumping from Sump -1), the northernmost line exhibited zero pressure and zero vacuum yet slowly discharged water. The middle line exhibited a slight vacuum (negative pressure) of - 0.073 pounds per square inch (psi). The southernmost line exhibited a positive pressure of approximately 60 psi. These three lines were further excavated to trace later in the season and the results are depicted on **Figure 1**.
